SANDIA REPORT

SAND2009-XXXX

Assembly and Comparison of Available Solar Hot Water System Reliability Databases and Information

David Menicucci

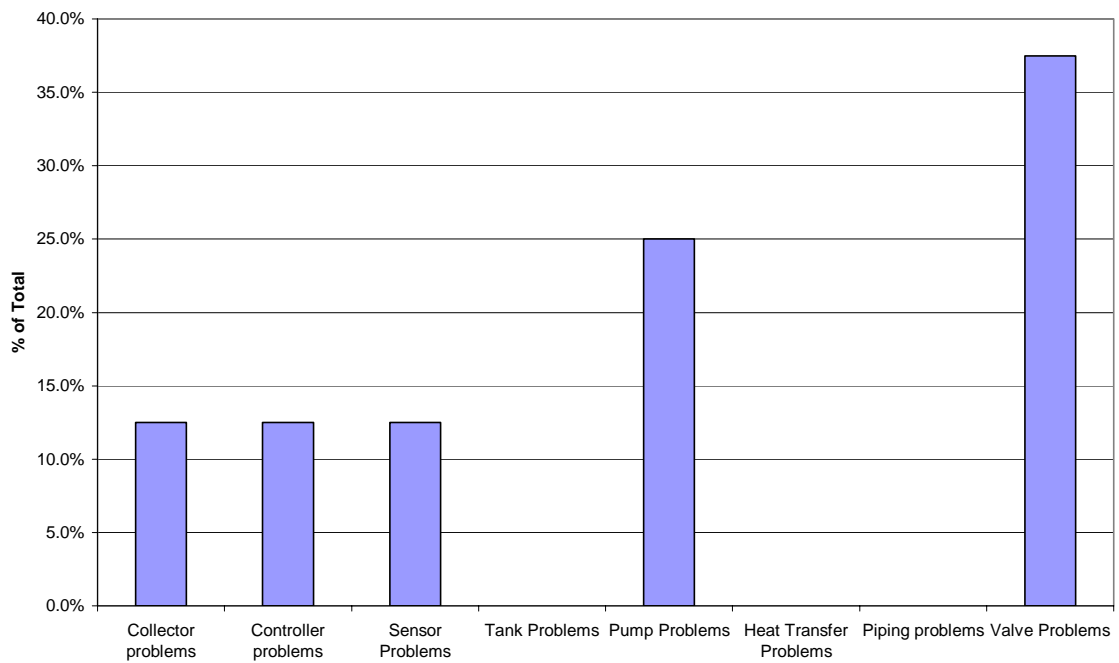
Figure 1. ICS Problems by Category.

Figure 2. Pumped Systems Problems by Category.

Figure 3. Thermosiphon Problems by Category.

Figure 4. PV-Controlled System Problems by Category.

Figure 5. Pool System Problems by Category.

The combined dataset, a worksheet labeled “Combo hi level sum,” provides a good starting point for the comparison. It contains the summary total problems for all three datasets. Figures 1 through 5 present a graphical breakdown of the problem areas, as a percentage of totals, for all of the major system types.

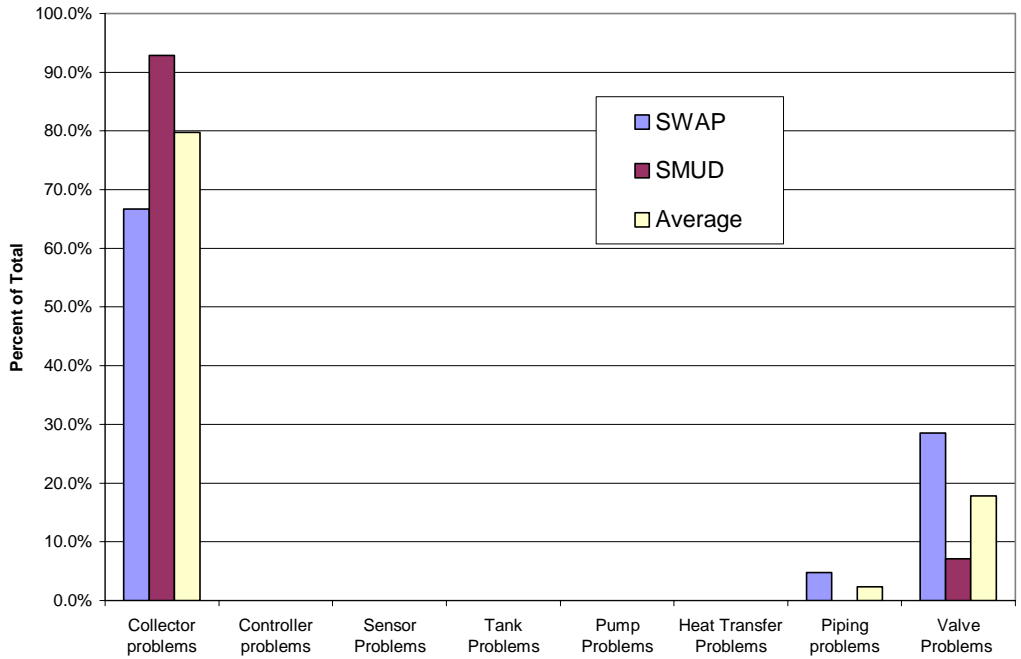
Figure 6. Comparison of ICS Problem Allocation.

Only two system types are common between the SMUD and SWAP datasets, ICS and pumped. Table 1 shows the problem totals for each system type expressed as a percentage of total problems. Figures 6 and 7 show the results of comparing the two summary problem datasets.

The ICS system has few moving parts to fail (Figure 6). Therefore, both datasets show the predominate failures to be with the collector itself. Among pumped systems, both datasets show similar trends and indicate that valves are the most problematic component (Figure 7). Collectors and controller problems seem to be more prevalent in the SWAP systems than at SMUD. Conversely, sensor, tank, and pump problems constitute a greater percentage of the problems at SMUD than in SWAP.

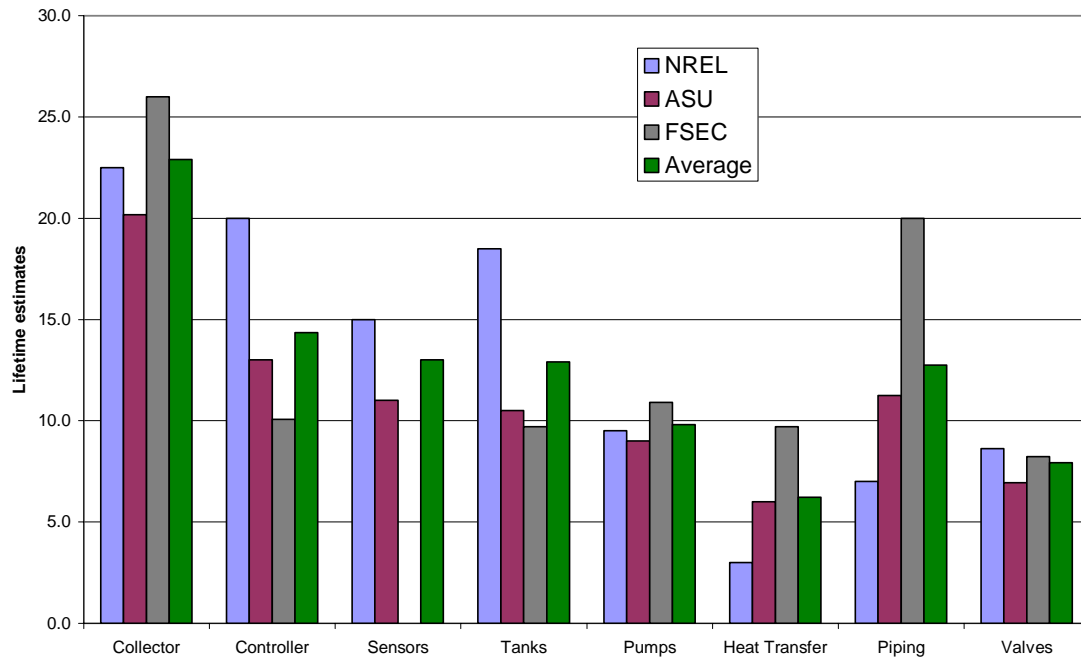
Figure 10. Comparison of Survey Results.

Figure 10 presents a plot of the results. There are no data in the FSEC survey relating to sensors.

While there is some consistency, there are some notable differences between the datasets. In the FSEC survey, piping lifetime estimates are much higher than in the others. This is probably due to how the questions were posed and how the results were consolidated. In the FSEC survey, “piping” referred to the piping material itself, which is often made of metal and long-lived. In the ASU and NREL surveys, piping insulation was noted as a separate item. Insulation is relatively short-lived. Both piping material and piping insulation were rolled up into the general category of “piping” in the database.

The other significant differences involve the category of tanks and controllers, both of which are estimated to have much longer lives from the NREL survey than in the other two. It is not clear how to explain these differences, but they are probably related to the problem just noted above.

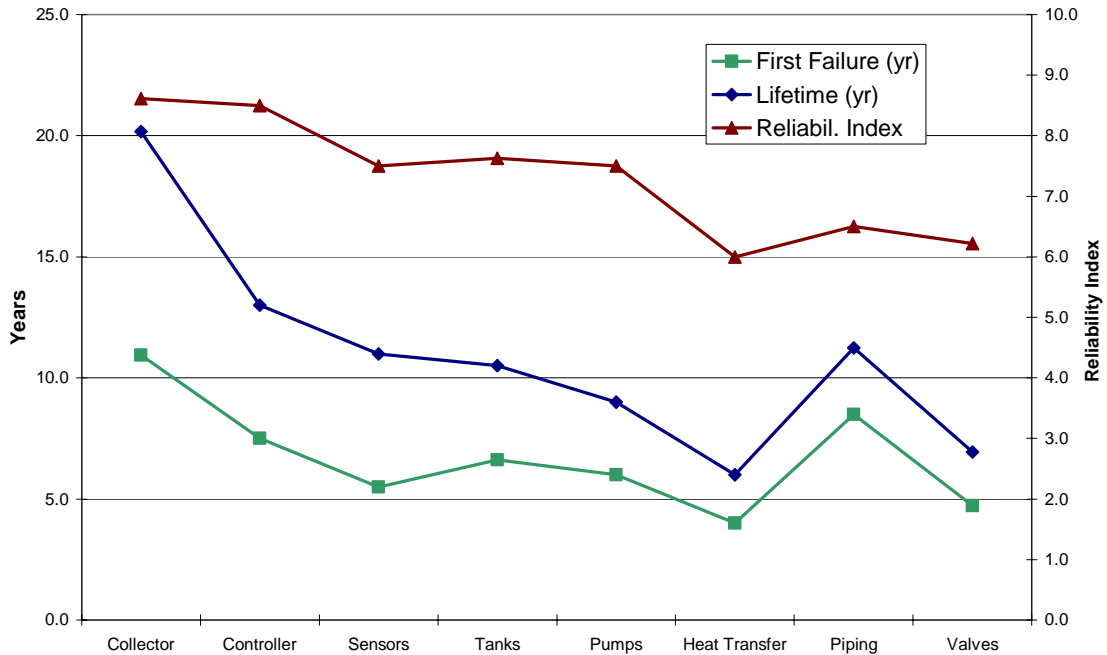
Figure 11. Summary of ASU Estimates.

The ASU survey produced some additional measures other than lifetimes. These are plotted in Figure 11 for information only. There is good consistency among these measures, as expected.

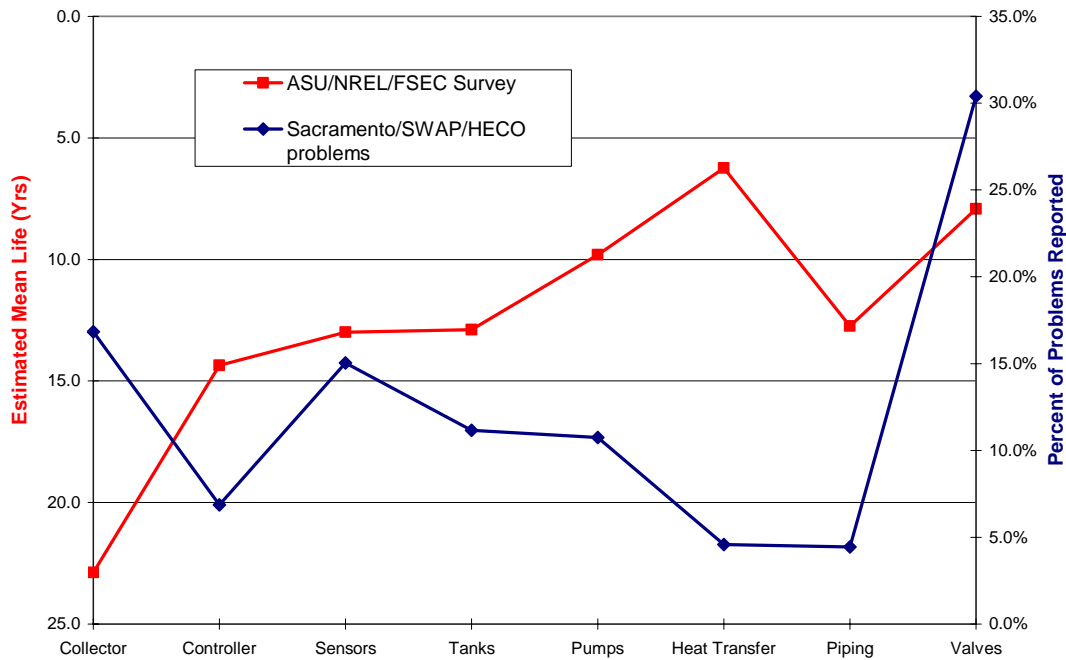
Figure 12. Comparison of Survey Results and Reported Problems.

Figure 12 shows this comparison graphically. On the abscissa is listed the component categories. On the right ordinate is the percent of problems reported (also called the proportion of problems) and has its scale oriented in the normal matter with the lowest value at the bottom and increasing vertically. On the left ordinate is the estimated mean lifetime (red line). Note that it is in reverse orientation, with the largest value at the bottom and descending vertically, because a long lifetime is expected to be inversely related to the number of field problems.

The plot shows little of the expected consistency. For example, based on the surveys a collector has a long projected life and, therefore, is expected to be less problematic in the field. But this is not what the field data show.

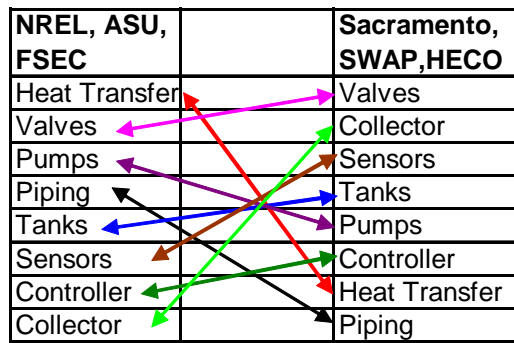
Figure 13. Sorted Comparison.

A way to compare these two basic sets of data is through a visual comparison after sorting, as was done in comparing the pumped systems between the SWAP and Sacramento datasets. Figure 13 shows the results. The survey list in the left-most column was sorted in ascending order according to average lifetime estimates. The field data on the right-most column were sorted in descending order according to the proportion of problems. Except for valves, there is little of the consistency that was expected.
